Villa Home Inspections

PROPERTY INSPECTION REPORT

Property Address: Address Omitted.
City, State, Zip: Inglewood, CA 90305.
Date of Inspection: May 9, 2008.
Time of Inspection: 04:00 PM.
Parties Present during Inspection: Listing agent. Buyers agent. Purchaser.
Inspector: Tony Escamilla.

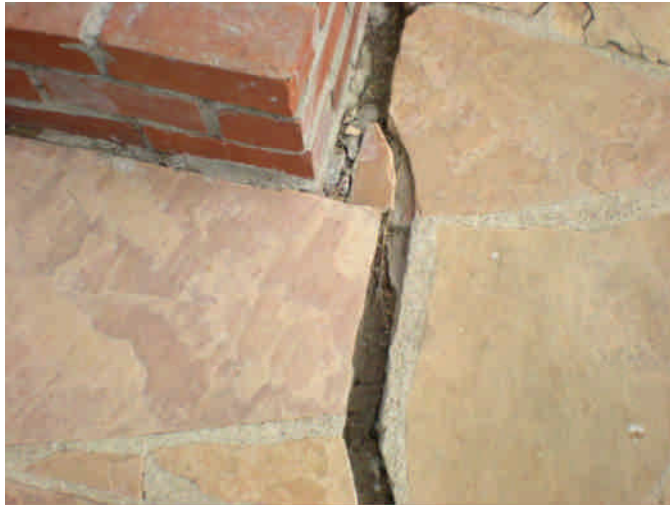
Walkways are damaged or broken. This may pose a trip hazard. Repair or replacement is recommended. See photo.

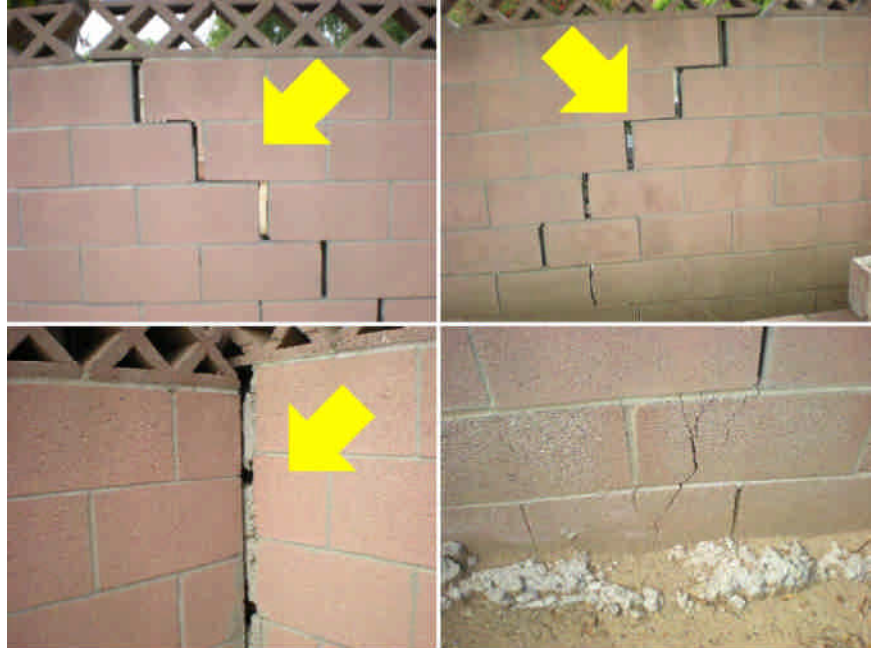
Wood gate is damaged or rotted. Repair or replacement is recommended.

Significant cracks noted on the block walls at time of inspection. Damage appears to be caused by tree roots from the adjacent tree. See photos. Further evaluation by a masonry contractor is recommended.

Block walls throughout the property are leaning or falling. Recommend further evaluation by a masonry contractor. See photo.

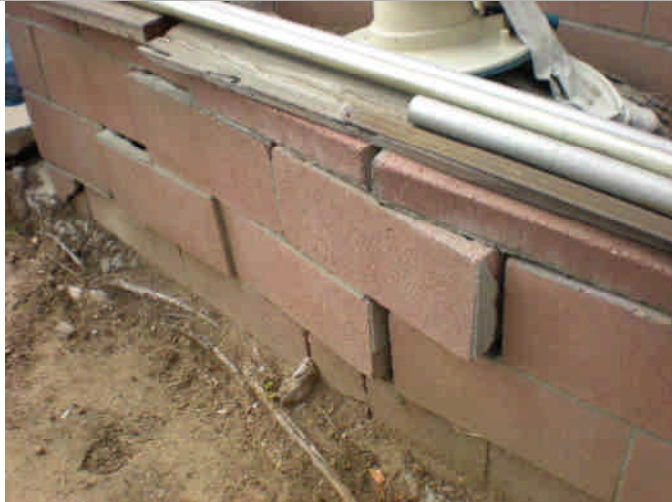
Trees are planted too close to the structure. Tree roots may cause damage to the foundation. Removal is recommended.

Trees or other vegetation are touching or overhanging the roof. Damage is possible. Vegetation on the roof is also a source for rodent activity on the roof and the attic. Recommend trimming all vegetation or trees away from the roof structure. See attic comments.

East block planter boxes have collapsed. See photo. Recommend further evaluation by a masonry contractor.

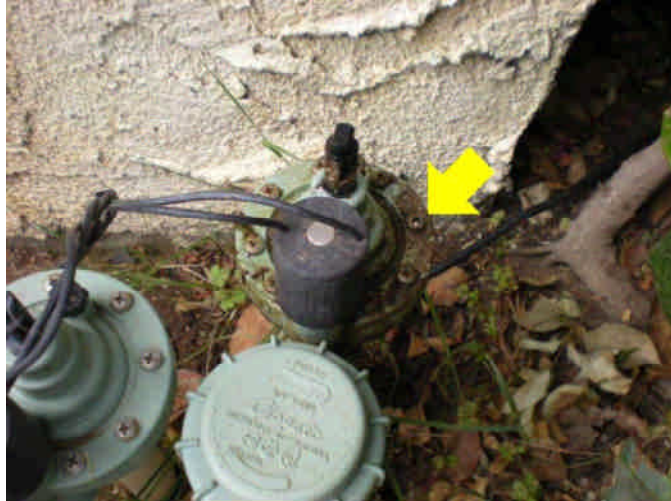
Front Yard: Sprinklers operated properly at time of inspection. Control valves leak when operated. Recommend further evaluation and repairs by landscaping contractor. See photo.

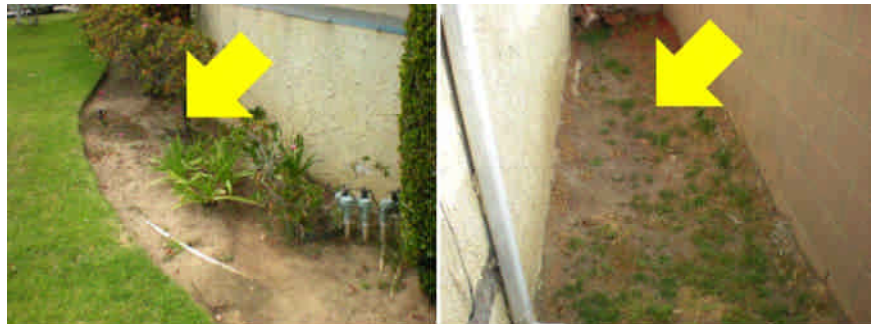
Planter areas near the house do not have a drainage system installed and retain water when it rains. This excess moisture, near the foundation of the house, can cause damage. Installation of a drainage system is recommended.

Signs of poor drainage observed at the west side of the property. Evidence of pooling water was observed at time of inspection. Block walls do not have weep holes installed at the bottom for proper drainage and cause water to pool. Installation of weep holes is necessary. Installation of a drainage system or regrading is recommended. See photo.

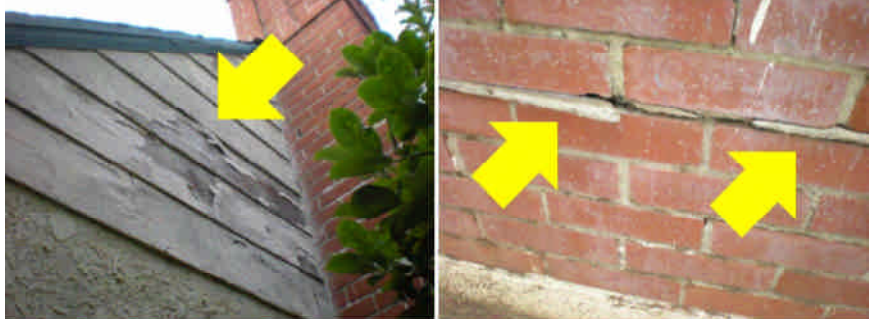
Moisture or rot damage observed on the wood siding. Further evaluation by a licensed termite inspector is recommended.

Paint finish is deteriorated or flaking. Repainting is recommended to prevent further moisture damage.

Deteriorated mortar observed between the bricks on the east and south wall veneer. See photo. Further evaluation by a masonry contractor is recommended.

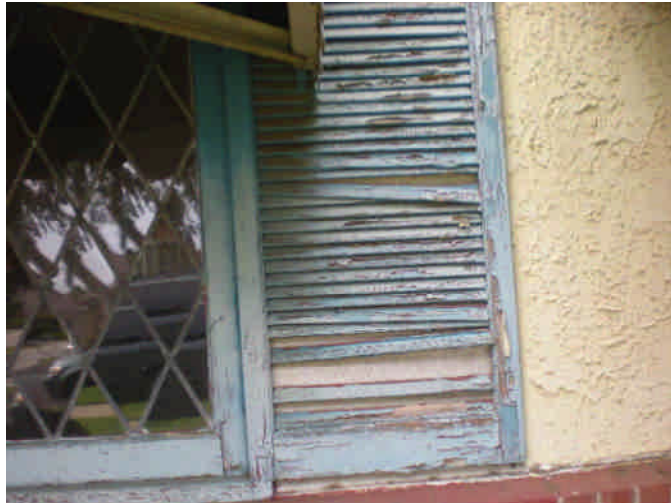
Wood window shutters throughout the house are damaged. See photo. Removal or replacement is recommended.

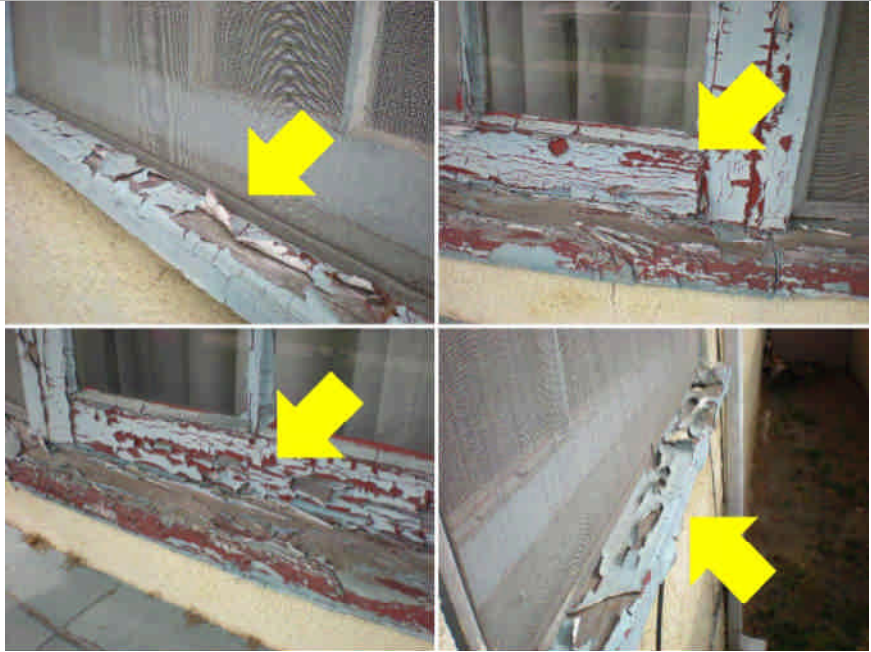
Wood. Double hung. Fixed glass. Caulking/glazing compound deteriorated. Replacement is recommended to prevent loose glass. Paint finish is deteriorated or flaking. Repainting is recommended. See photo. East round window glass is broken. Replacement is recommended.

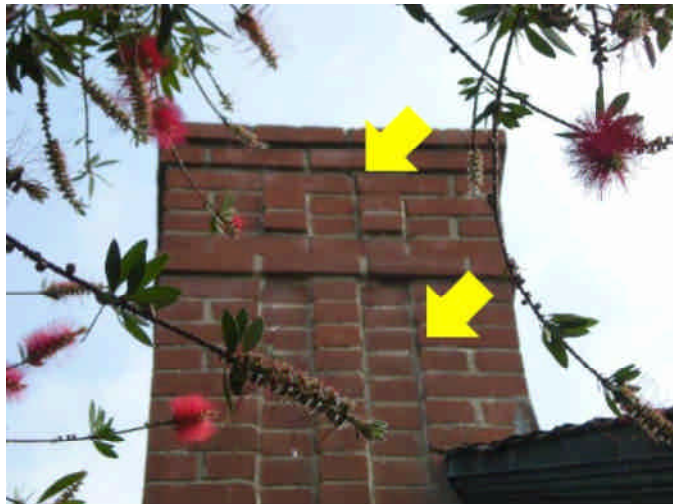
No rain cap installed on either chimney. Installation is recommended to prevent moisture penetration and damage.

Minor deterioration of the mortar between the bricks was observed on the east chimney. See photo. Typical maintenance is recommended.

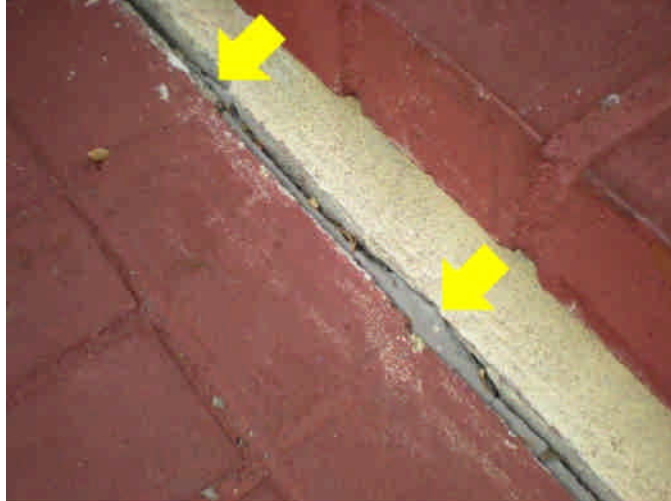
Moderate settlement noted. Recommend further evaluation by a masonry contractor. See photo.

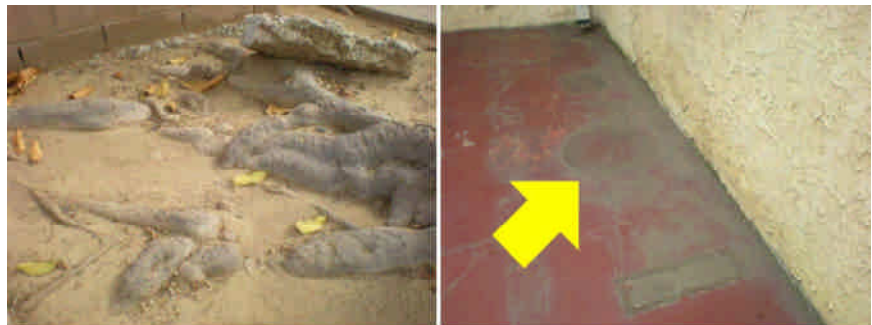
Cracks noted are significant at the north patio area. Significant raised areas observed, due to tree roots from adjacent tree. You may want to consider removal of the tree and replacement of the concrete floor.

Cracks noted are typical on the west patio area, adjacent the house. Poor drainage noted. Evidence of pooling water observed. Installation of a drainage system is recommended. See photo.

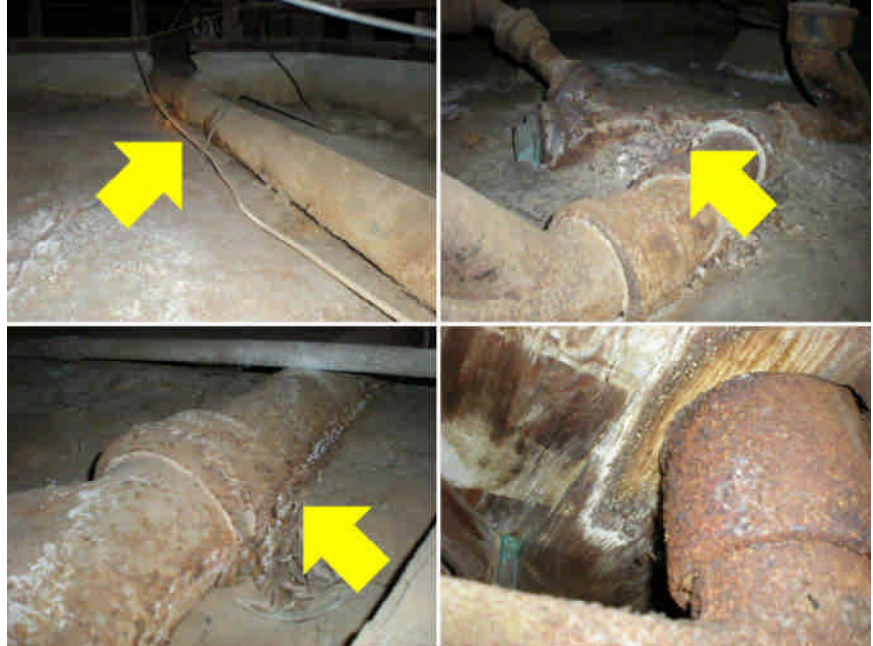
System appears to be nearing/at end of its useful life . Significant corrosion observed on the drain lines at time of inspection. See photos. Further evaluation by plumbing contractor is recommended.

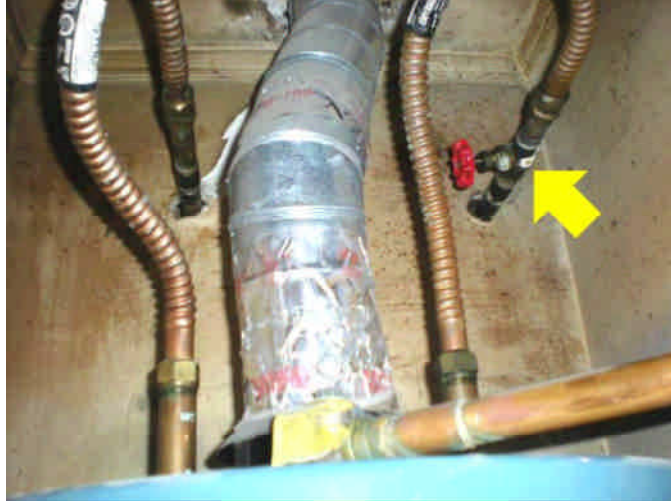
Minor corrosion/rust noted on the water supply lines. See photo.

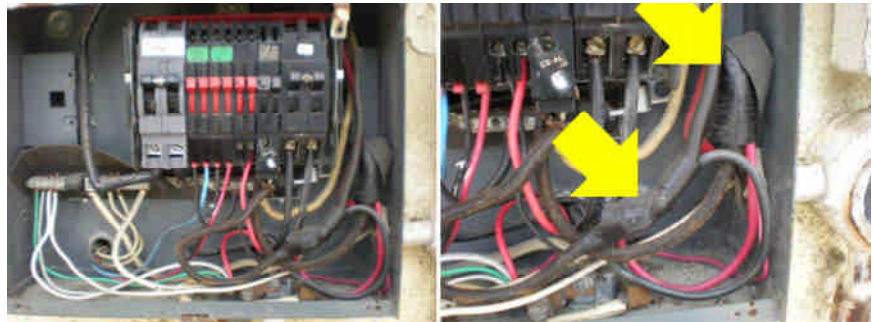
Panel Grounding: No observable grounding system noted. This may indicate an older, outdated electrical system. You may want to consider installing a grounding wire or upgrading the panel.

Main Panel Condition: Improper taps observed at the 220 volt circuits. Breakers are overloaded with more than one circuit. Each breaker should have only one circuit attached. See photos. Have a licensed electrician make further evaluation and corrections as needed.

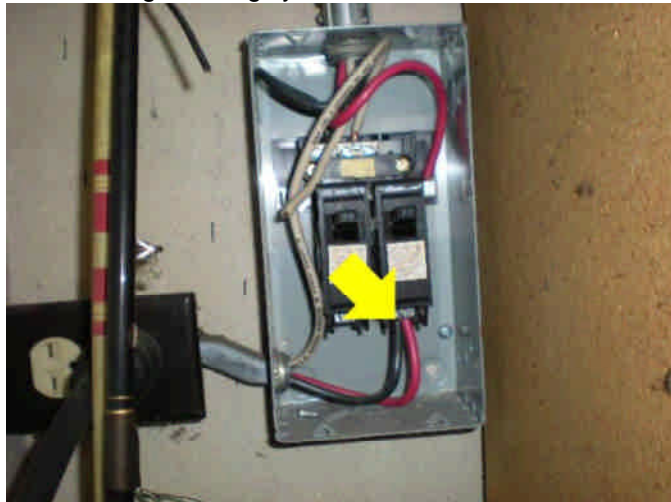
Panel Condition: One or more breakers are overloaded at the main panel (Multiple wires are connected to a single lug on a circuit breaker where only one wire should be connected). See photo. Missing interior panel cover. Replacement is necessary for safety. Have a licensed electrician make further evaluation and corrections as needed.

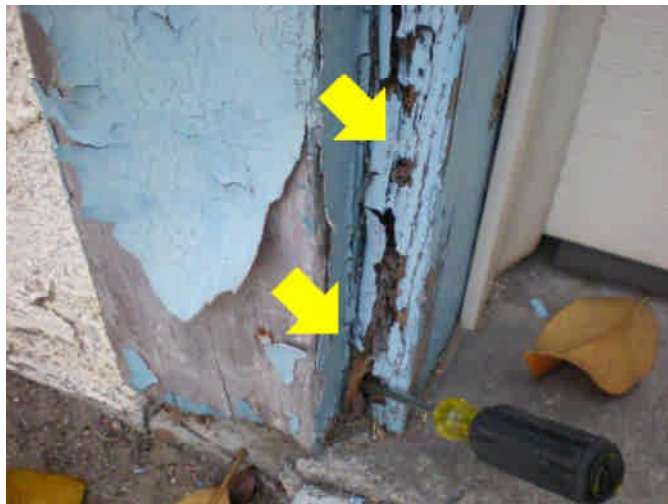
Door operated properly at time of inspection. Automatic door opener is operational. Automatic reverse feature is operational. Termite or rot damage noted at the door jamb at time of inspection. See photo. Further evaluation by licensed termite inspector is recommended.

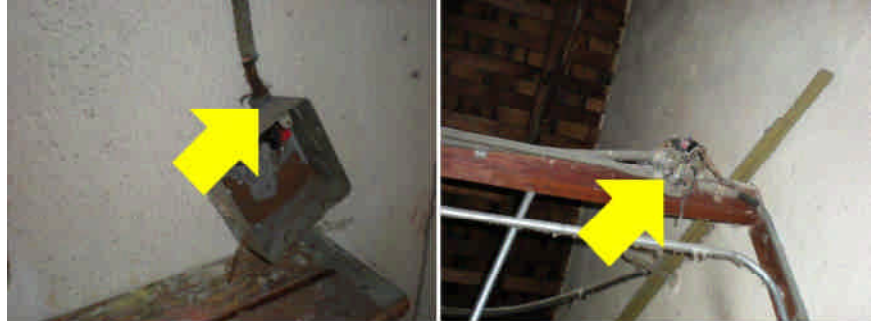
Exposed electrical wiring observed at time of inspection. Proper installation is required. Recommend exposed wiring be properly protected. Junction box covers are missing. Installation is required. See photo.

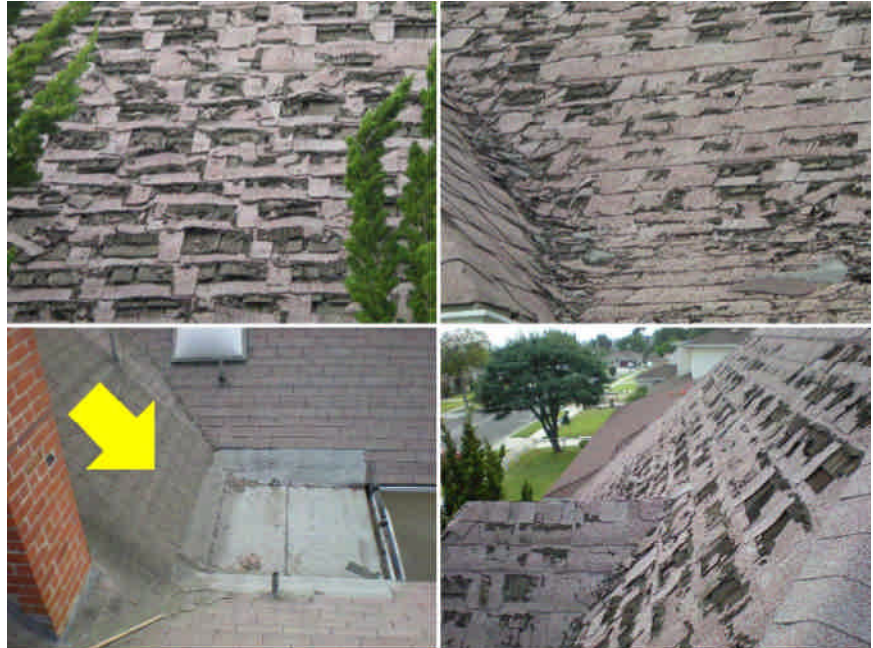
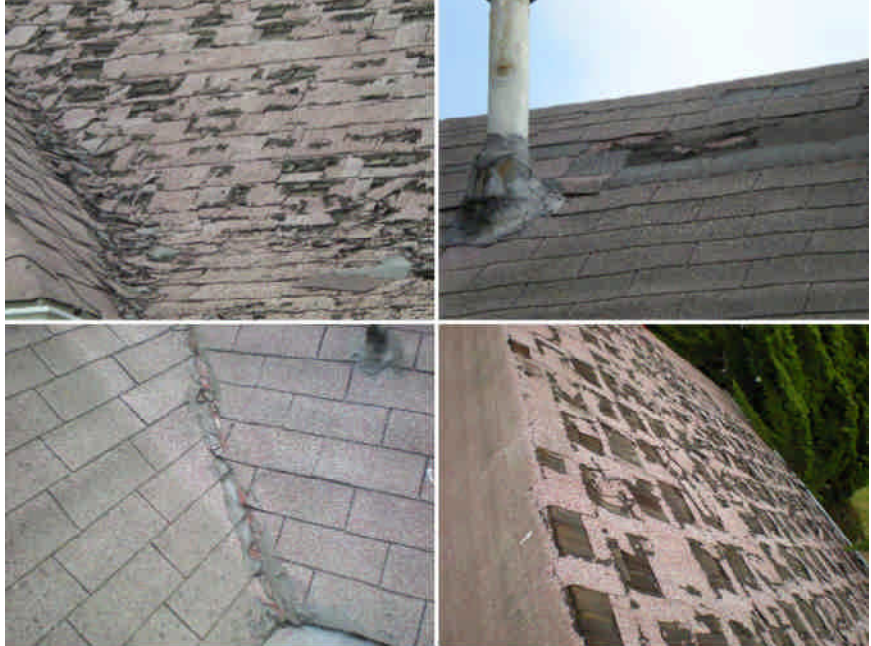
Roofing material appears to be at or near the end of its useful life. Significant deterioration of the roofing material was noted at time of the inspection. Evidence of significant moisture penetration was found inside the dwelling. A licensed roofing contractor should be called to make further evaluation and repairs as needed.

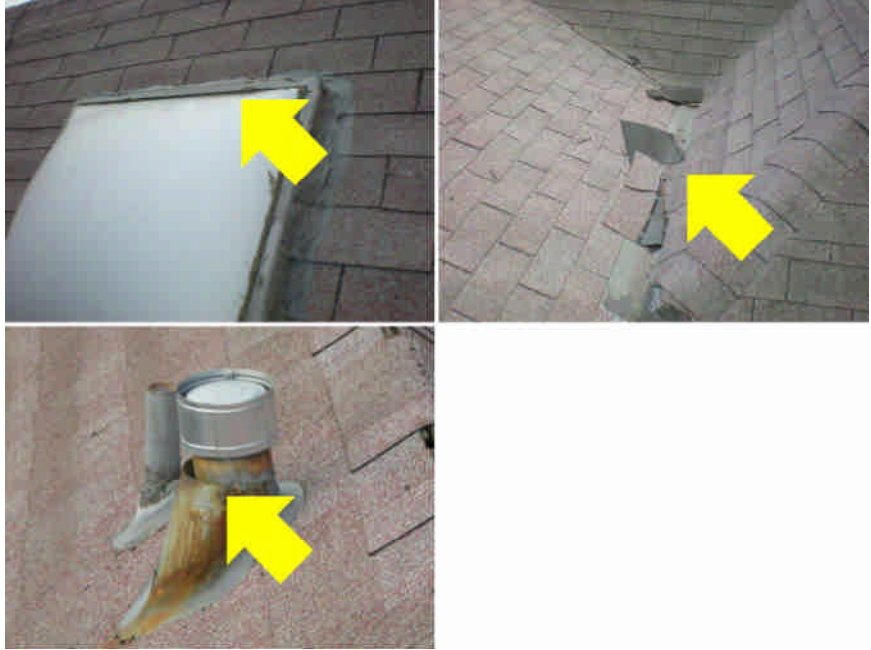
Metal. Flashings do not appear to be properly sealed at the following locations:
at the vent pipes. Typical maintenance is recommended.

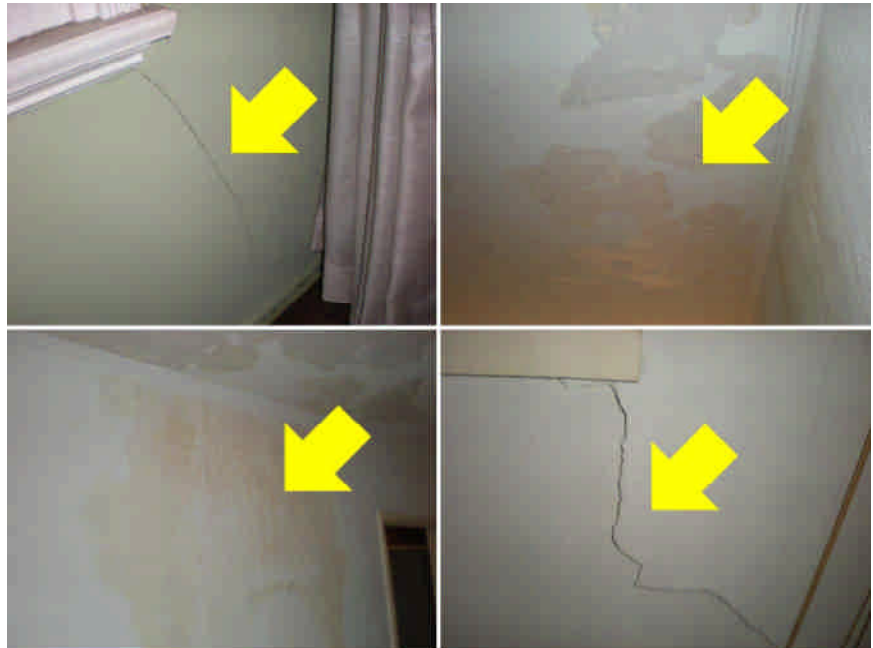
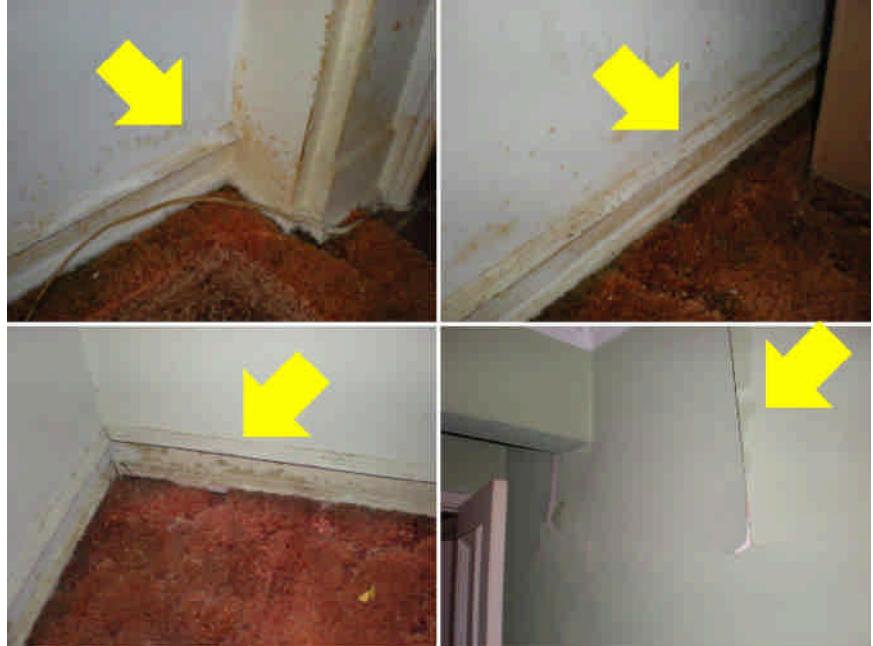
Type: Plaster. Condition: Cosmetic damage. Cracks underneath the windows. Wall paper is falling off. See Photo. Removal and repainting is recommended.

Condition: Moisture stains/damage viewed on the walls and ceilings. Possible roof leaks. Further evaluation and repairs as needed by a roofing contractor is recommended. Significant cracks noted at time of inspection. See Photos. Cracks do not appear to be structurally significant at time of inspection. See foundation comments and photos.

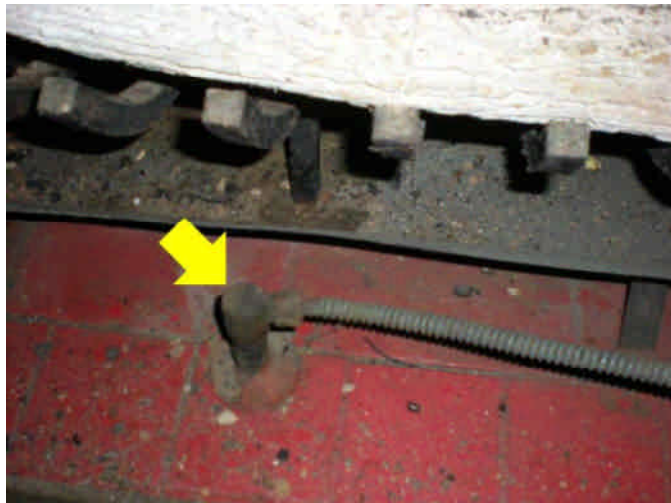
Location #1: Family Room. Type: Masonry. Gas burning. Wood burning. No damper is installed. Recommend cleaning before use.

Flexible gas line observed inside the firebox. This is a potential hazard and not allowed. Replacement with a rigid pipe is necessary.

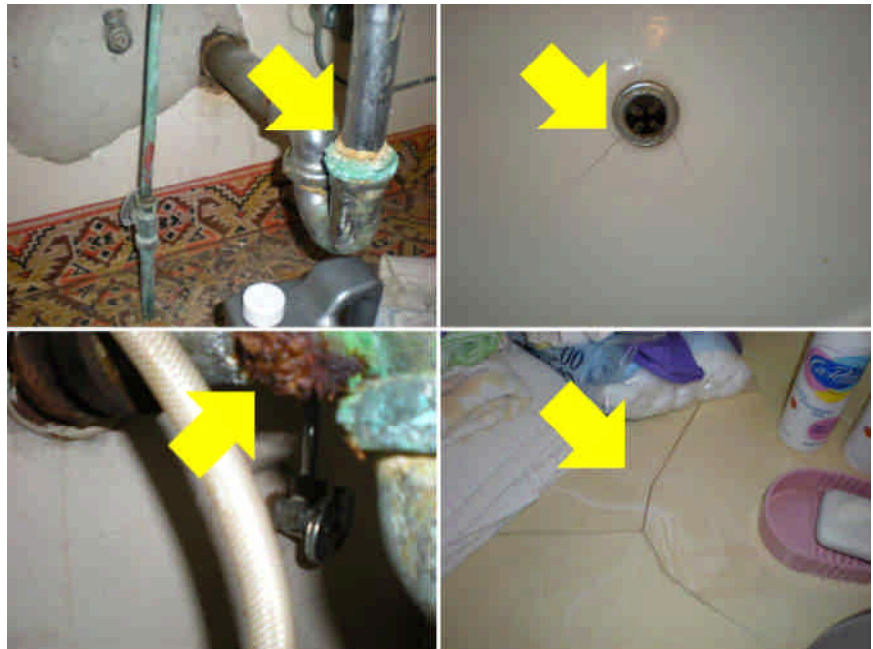
Bathroom # 1: Sink & Vanity Condition: Sink surface is damaged or worn. Repair, resurfacing or replacement is recommended. Counters/cabinets appear serviceable. Plumbing Condition: Rust/Corrosion noted at the drain line. A licensed plumber should be called to make further evaluation and repairs as needed. See photo.

Bathroom # 2: Sink & Vanity Condition: Sink is in functional condition. Cabinet appear serviceable. Countertop is broken. See photo. Replacement is recommended.

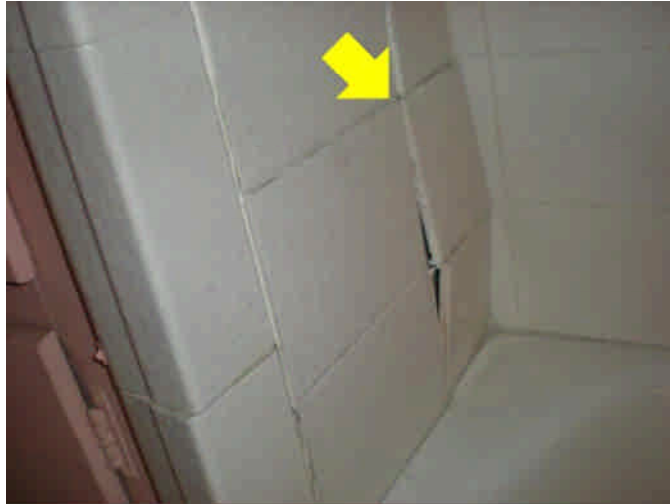
Bathroom # 1: Shower pan tiles are damaged or not properly sealed. A shower pan test by a plumbing contractor is recommended to determine water tightness. Shower pan tests take time and are not included as part of this inspection. Shower door is damaged or does not close properly. Repair or replacement is recommended. See photo.

Bathroom # 2: Moisture damage is seen at wall areas. Shower door is damaged or does not close properly. Repair or replacement is recommended.

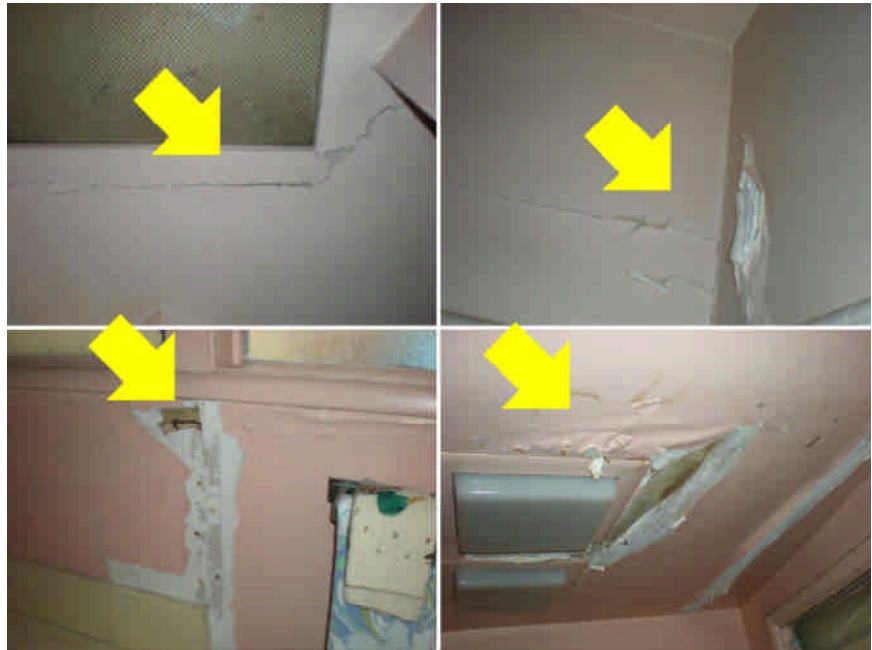
Bathroom # 2: Type: Plaster. Condition: Moisture stains/damage viewed on the walls and ceiling. Roof appears to be leaking at the skylight. See Photos. Further evaluation by roofing contractor is recommended.

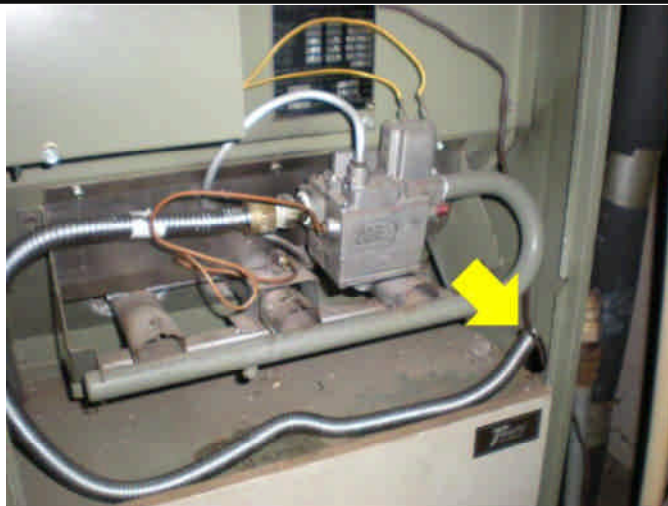
Unit is dirty or has heavy dust build up. Cleaning is recommended prior to attempting operation. Flexible gas connector passes through the appliance wall. This is not allowed as vibration from the unit can cut or damage the gas line, causing a leak or explosion. Replacement is recommended. See photo.

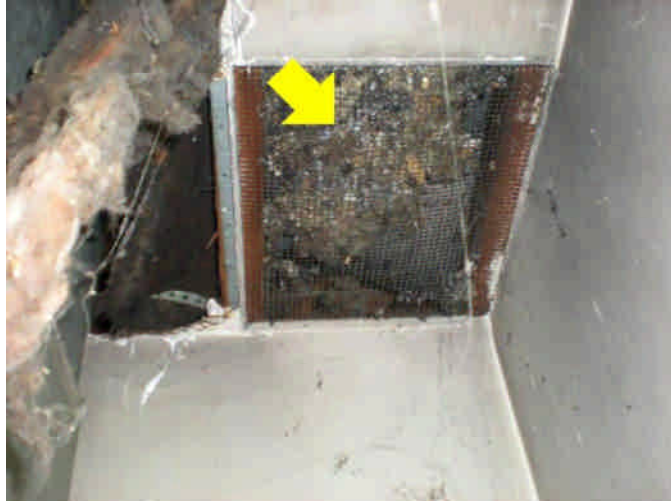
Combustion air vent openings are blocked or dirty. This may cause improper combustion and noxious gases like carbon monoxide. Removal of any blockage is necessary. See photo.

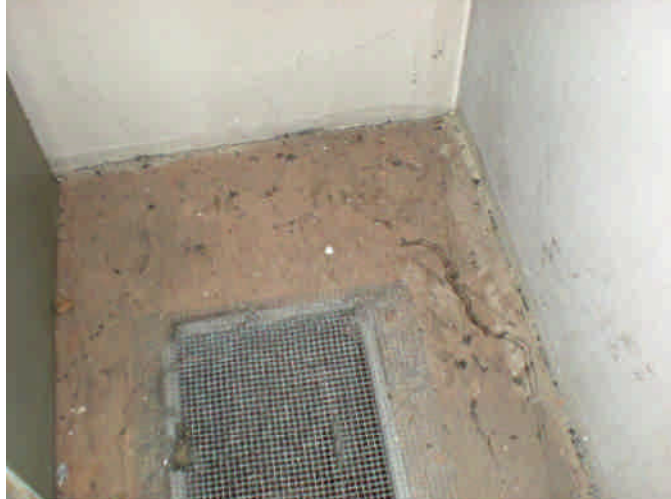
Evidence of rodent activity was observed near the HVAC system. Further evaluation by pest control company is recommended. See photo.

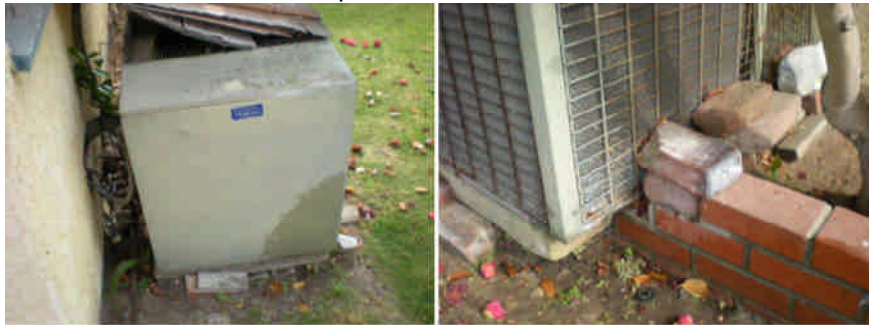
Condensor is unlevel. Condenser unit is dirty. Cleaning/maintenance is recommended. Evaporator is not properly sealed. Retaping is necessary.

Unit produced warm air only during inspection. Recommend further evaluation and repairs as needed by HVAC contractor.

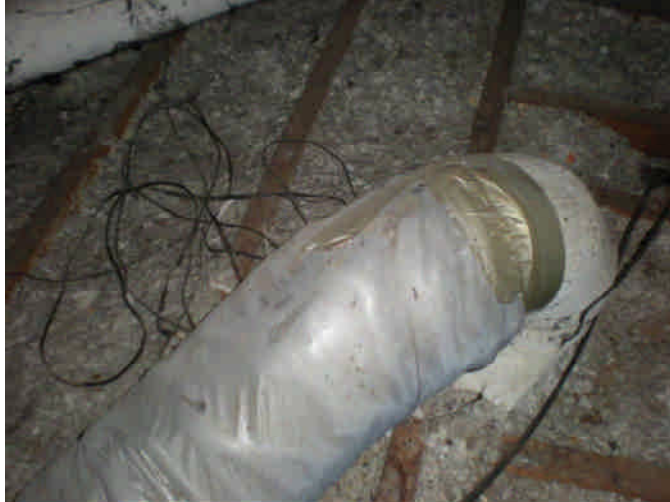
Appears serviceable. It should be noted that dried rodent droppings have been known to cause illness in humans. Due to past or present rodent activity in the attic, you may wish to consider having a thorough cleaning of the inside of the heating and air conditioning ducts performed by a licensed duct cleaning specialist prior to use of the system. See photo.

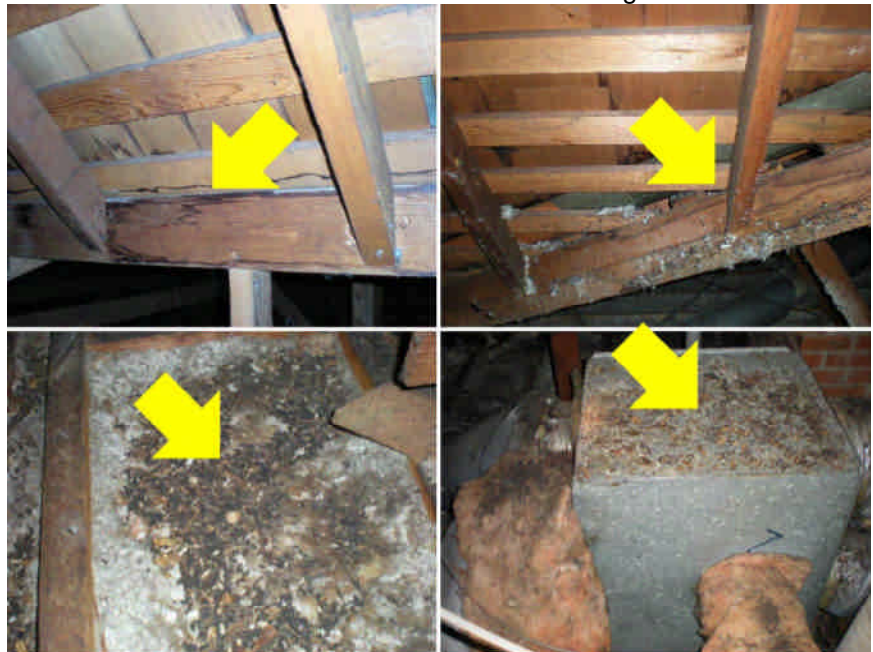
Significant staining observed in the attic, from roof leaks. Signs of past or present leakage at the roof valleys. See roof comments and photos. Further evaluation by roofing contractor is recommended.

Evidence of rodent activity was noted. You may wish to have treatment carried out by a licensed exterminator.

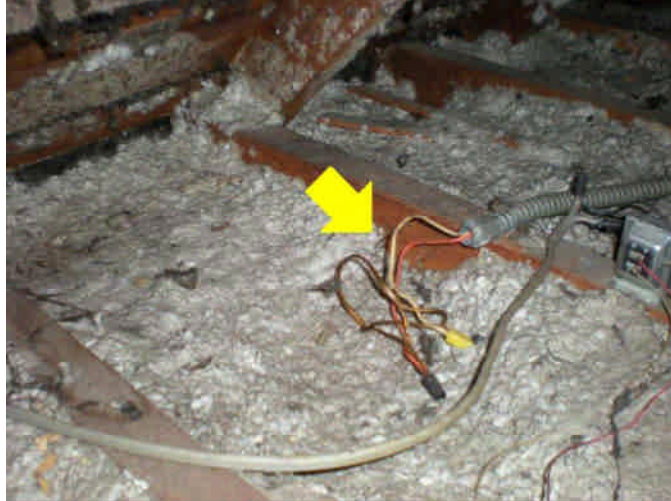
Improper or exposed electrical wiring noted. All electrical connections are required to be inside a covered junction box. Proper installation is necessary. See photos.

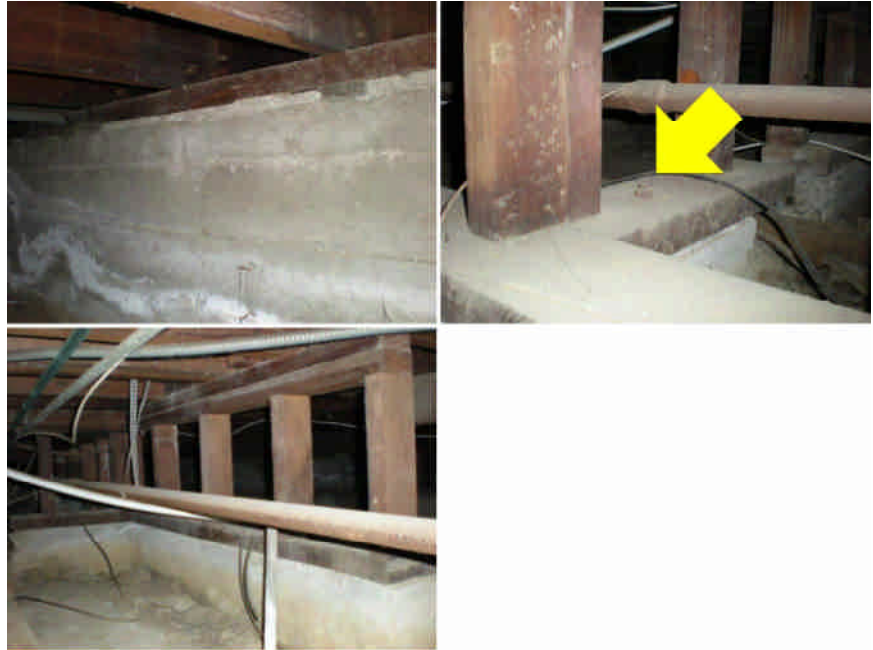
No visible problems noted at time of inspection. Anchor bolts are present and functional. Minor settlement cracks noted, not significant at this time. See photos.

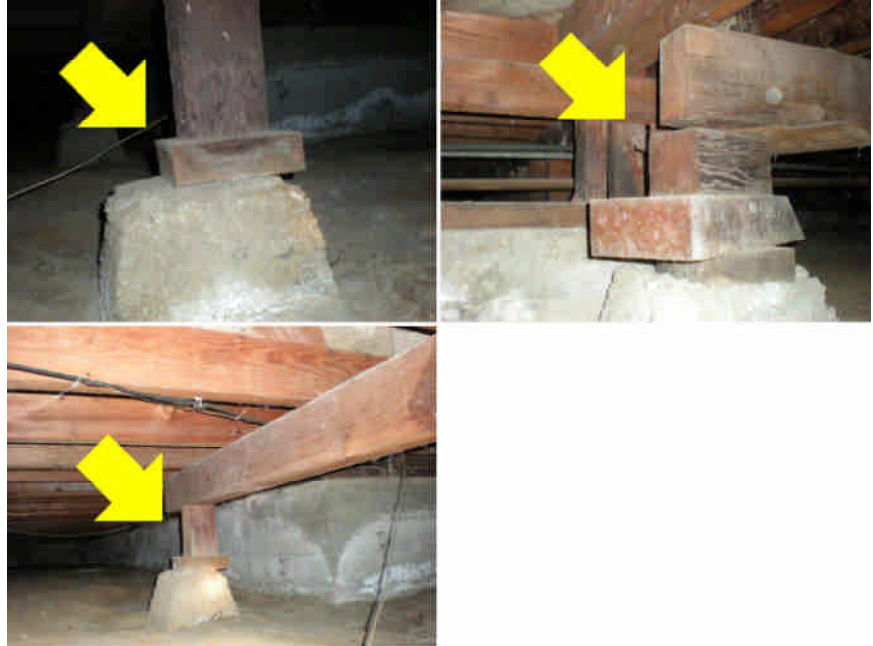
One of more of the wooden posts supporting the floor frame is not properly centered on the concrete base (pier) and not providing adequate support. See photos. Proper installation is necessary to prevent unlevelled floors. Recommend further evaluation and repairs by a licensed general contractor.
