Villa Home Inspections

PROPERTY INSPECTION REPORT

Property Address: Address Omitted.
City, State, Zip: Inglewood, CA 90305.
Date of Inspection: May 9, 2008.
Time of Inspection: 04:00 PM.
Parties Present during Inspection: Listing agent. Buyers agent. Purchaser.
Inspector: Tony Escamilla.

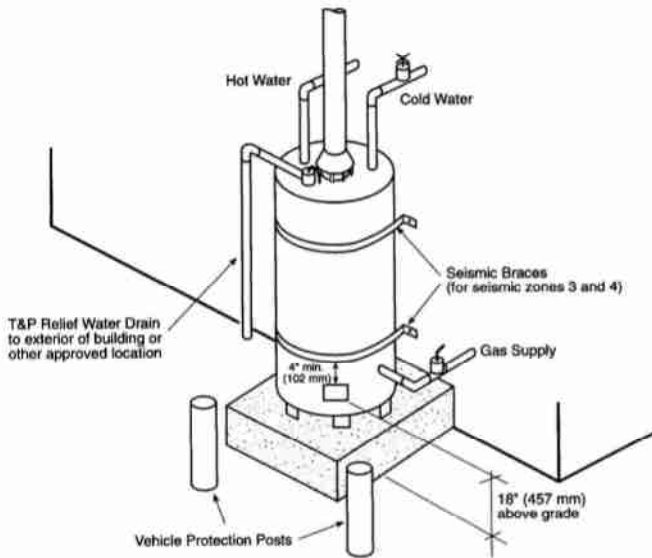
WATER HEATER REQUIREMENTS

Minor corrosion/rust noted on the water supply lines. See photo.

UPC (Uniform Plumbing Code) section 608.5 requires a minimum of 3/4 inch Temperature Pressure Relief Valve (TPRV) be installed with an overflow pipe terminating no less than 6 inches from the ground. Overflow pipe may not have any traps, reductions or threads.

UPC (Uniform Plumbing Code) section 510.5 requires 2 approved seismic straps (no "plumbers tape") at the top 1/3 and bottom 1/3 of the heater, at least 4 inches away from the controls.

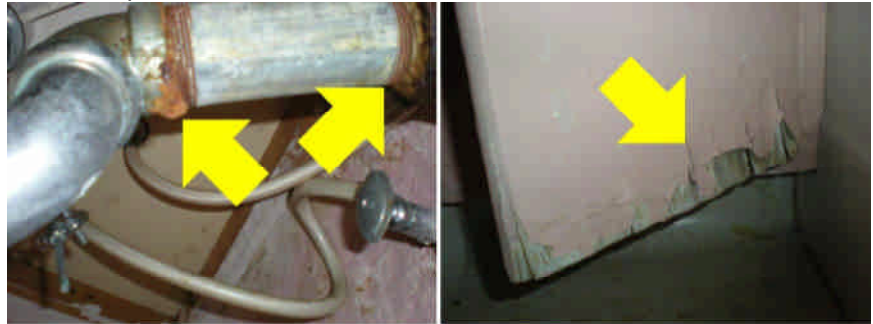
ADDITIONAL PHOTOS:

Plumbing Condition: Water service was off underneath sink at time of inspection. Inspection of the plumbing fixtures was not possible at time of inspection. Faucet appears to be leaking. Evidence of previous leakage was noted at the drain line under the sink. Rust/Corrosion noted at the drain line. A licensed plumber should be called to make further evaluation and repairs as needed. See photos.

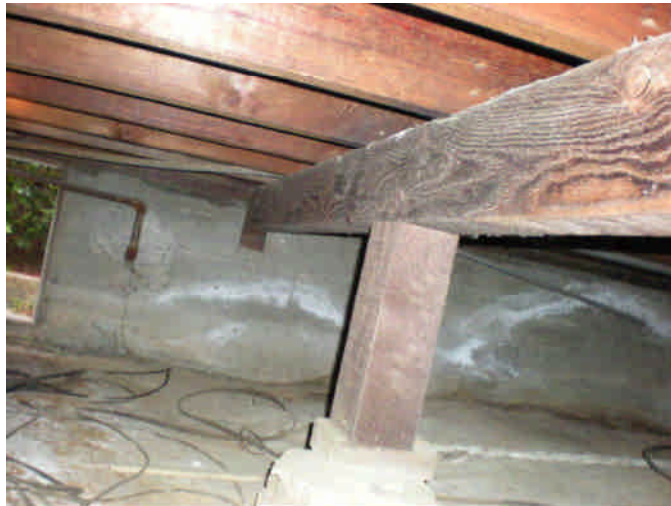
No visible problems noted at time of inspection. Anchor bolts are present and functional. Minor settlement cracks noted, not significant at this time. See photos.
